**CALIFORNIA REGIONAL WATER QUALITY CONTROL BOARD - SAN DIEGO REGION  
WATERSHED MANAGEMENT PROGRAM**

**FACILITY INSPECTION REPORT**

**INSPECTION DATE:** 10 April 2006

**FACILITY:** Carlsbad Municipal Golf Course

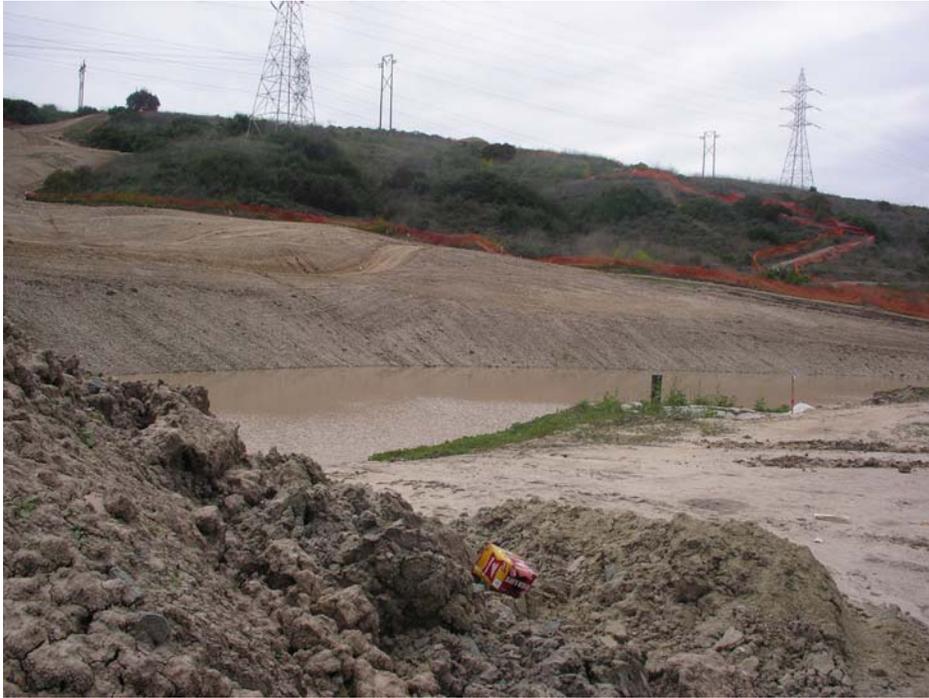
IMGP0157.JPG

**IMGP0157.JPG** looks to the west toward Hidden Valley Road and displays one of the site's several sediment detention basins.

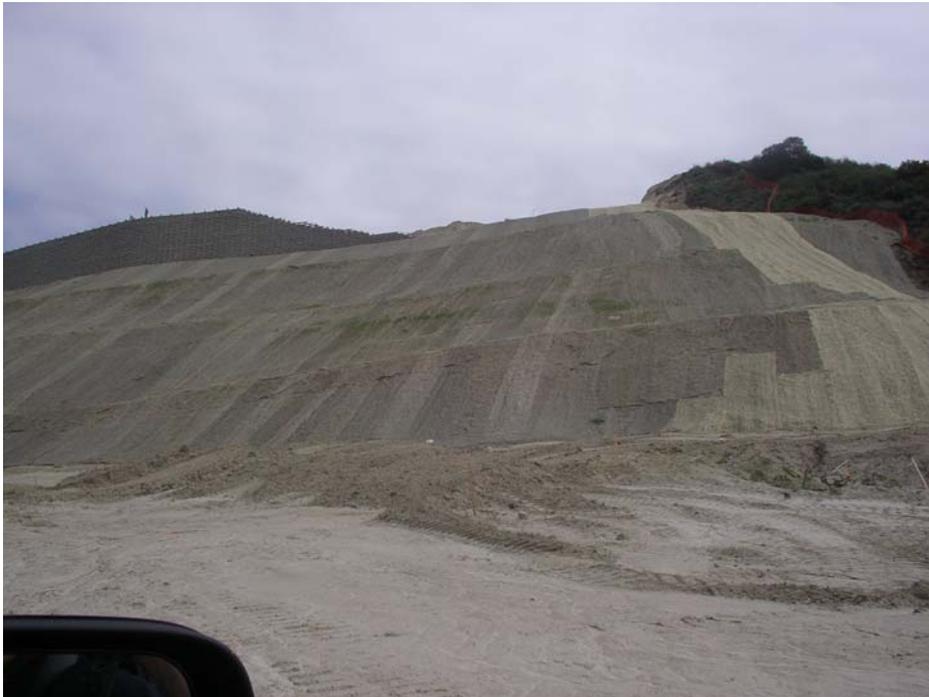
IMGP0158.JPG

**IMGP0158.JPG** looks to the southeast toward College Boulevard and displays one of the site's steepest slopes. The City can be seen here installing erosion control mats on the slope.

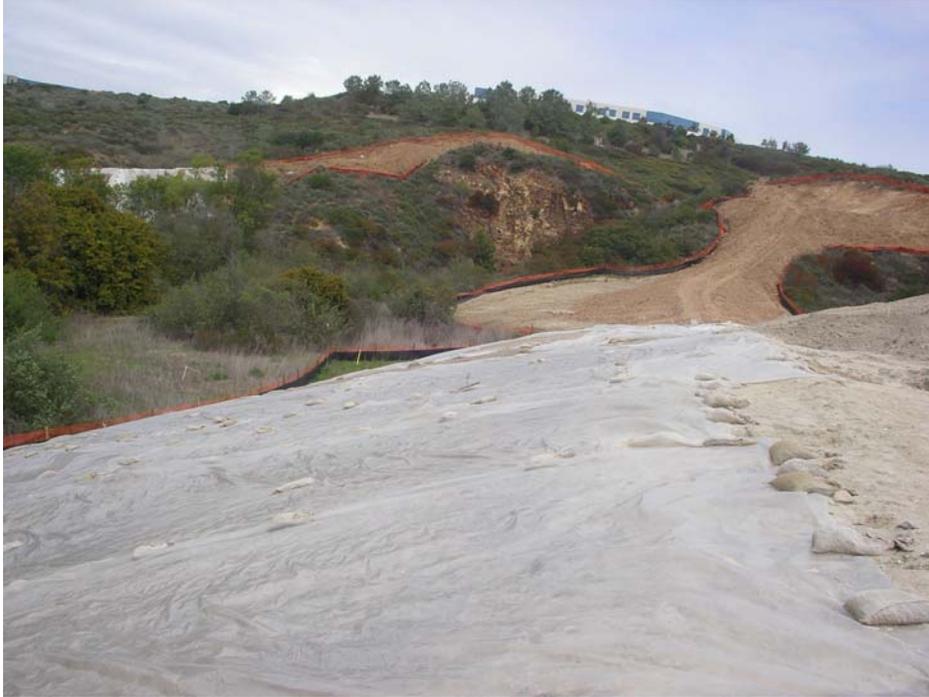
IMGP0159.JPG

**IMGP0159.JPG** looks to the northeast toward Faraday Avenue and displays a plastic covered slope. At the bottom of the slope, the City has installed reinforced silt fences. Covering the slopes with plastic is a temporary erosion control method that allows the City to protect the slope, but to also permit quick reshaping of the slope in the future.

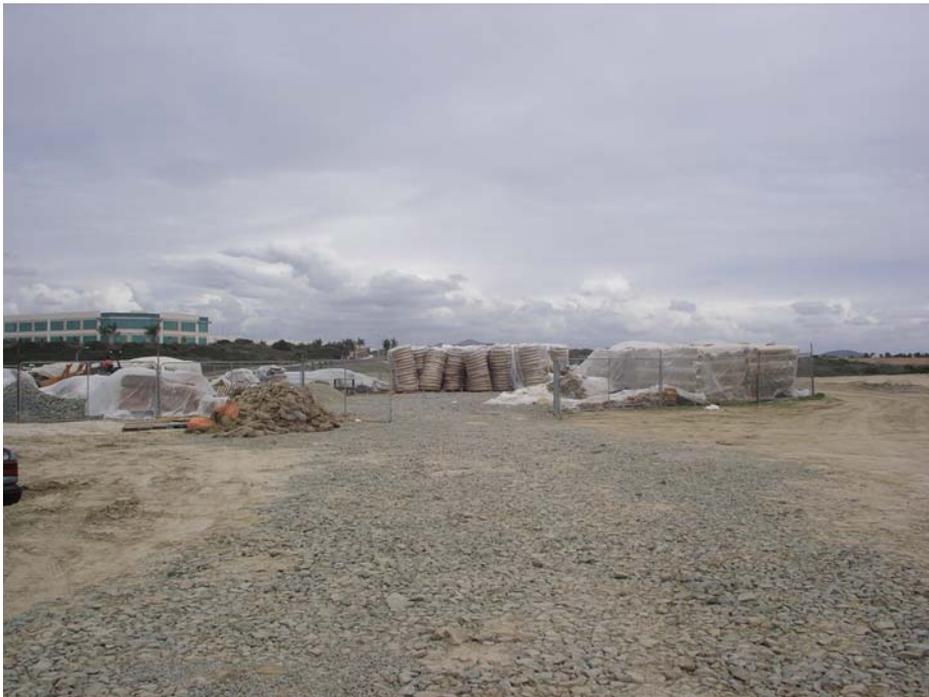
IMGP0163.JPG

**IMGP0163.JPG** looks to the northeast toward College Boulevard and displays the BMP stock pile/supply. The City has strategically stored erosion control materials in the event of a storm.
